Baler operation takes a **tragic** turn

No warnings, guards, or safety analyses on the route to injury

Extra wiring is a real firestarter

Vent line missing from drawing; five workers burned

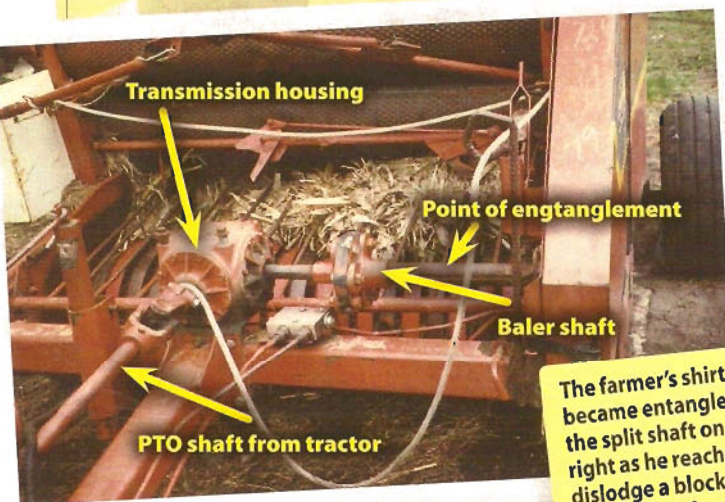
Emergency responders found the farmer's shirt had wrapped around the rotating power take-off (PTO) shaft to the baler, pulling him toward the machine and breaking his neck. He was pronounced dead at the scene.

It appeared the farmer left the tractor idling and the PTO running while he tried to dislodge some cornstalks that were stuck in the conveyor that moves stalks or hay into the baler mechanism. The spinning PTO driveline caught his shirt and pulled him to his death against the baler housing.

The farmer's shirt became entangled in the split shaft on the right as he reached to dislodge a blockage. The rotating shaft wound up his shirt until he was pulled against the shaft, breaking his neck and killing him.

Investigators determined the accident would not have happened if the guards had been present or if the farmer had disconnected the baler from the PTO before trying to remove the blockage.

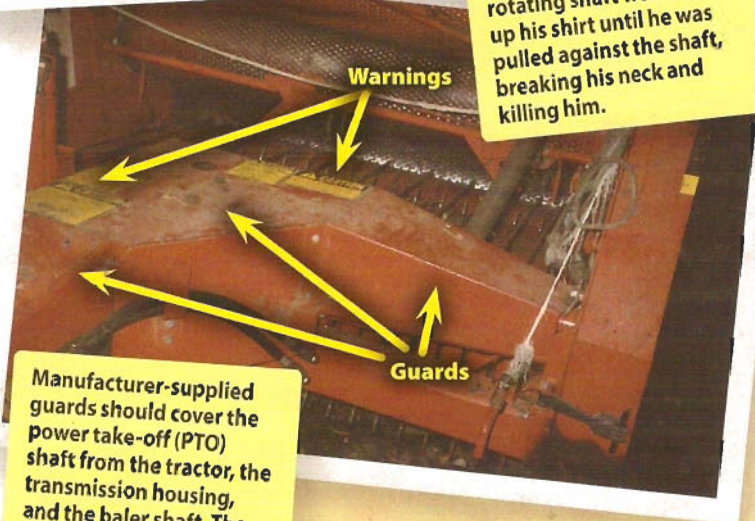
The farmer had completed some repairs to the round baler before removing it from the equipment dealer's premises, but the machine did not have the manufacturer-supplied guards when he traded for it or when he took it home. The guards are meant to cover the PTO shaft from the tractor, the transmission housing that couples the PTO to the baler shaft, and the baler shaft itself.

Manufacturer-supplied guards should cover the power take-off (PTO) shaft from the tractor, the transmission housing, and the baler shaft. The guards also warn against removing them during operation, approaching rotating components, and servicing the baler without disconnecting the PTO.

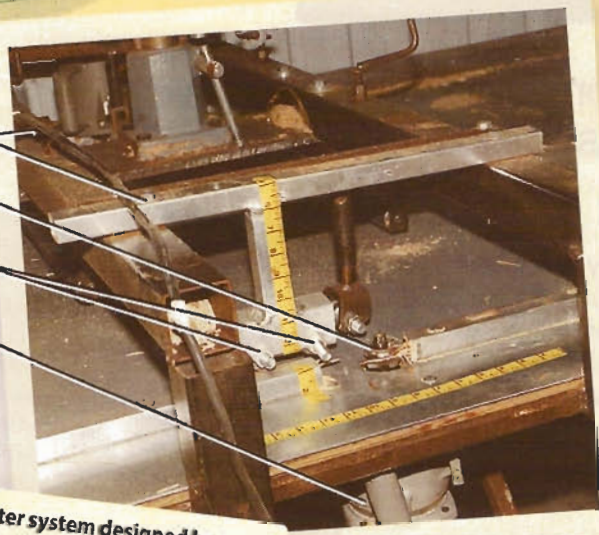
The clamp-adjustment bolts had a habit of working themselves loose after about 5 min of operation. To tighten them, workers had to apply a crescent wrench to the bolts, located about 7 in. above the router bit.

Disconnecting the power was the only way to stop the router bit from spinning; there was no emergency kill switch or on-off control on the router. In addition, the router's bit was not guarded.

The router system designed by the contracting company had an unguarded router bit and a board-hold-down mechanism that required frequent adjustment. The router could only be powered off by unplugging it, so the operator adjusted it while bit was spinning. His wrench slipped, and his hand hit the spinning blade.

If the machine's designers had conducted a safety analysis, they would have seen the need for an accessible power-off mechanism and proper guards against both intended and reasonably foreseeable uses. After the accident, the contracting company added a metal guard over the router bit.

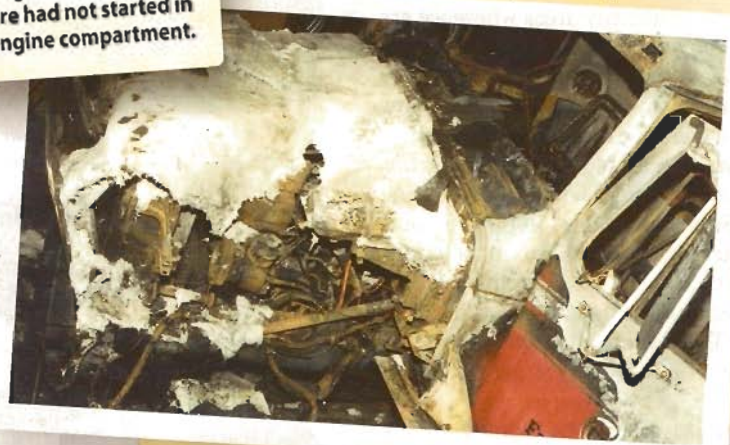
The edges of the fiberglass hood had burned away, but its center had simply melted. The front tires and some other combustible material in the engine compartment were intact, leading investigators to rule out the engine compartment as the point of ignition.

An overnight fire melted and partially burned a delivery truck's fiberglass hood. Because the hood, combustible materials in the engine compartment, and front tires were mostly intact, investigators determined the fire had not started in the engine compartment.

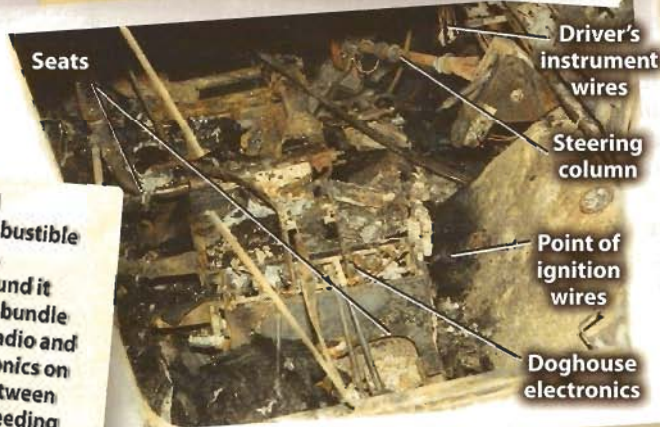
Wires near the steering wheel that fed the driver's instrument cluster were mostly intact. However, wires that led to the CB radio and other accessory instruments mounted on the "doghouse" between the passenger and driver seats were broken and bare of insulation. Investigators determined that the accessory wire bundle was the point of ignition.

The fire burned everything combustible in the truck cab. Investigators found it started in a wire bundle that fed the CB radio and accessory electronics on the doghouse between the seats. Wires feeding the driver instrument cluster were intact.

In this case, the wires serving the truck's CB radio and supplementary instrument cluster ignited and set the truck on fire. Those who installed the CB radio and other electronics in the cab should have been careful to protect wires from vibration and wear with grommets. **MD**

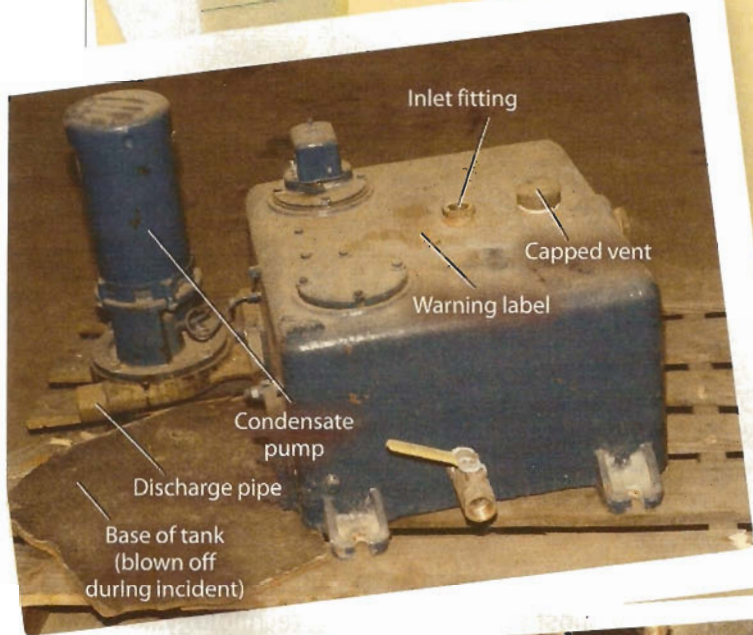
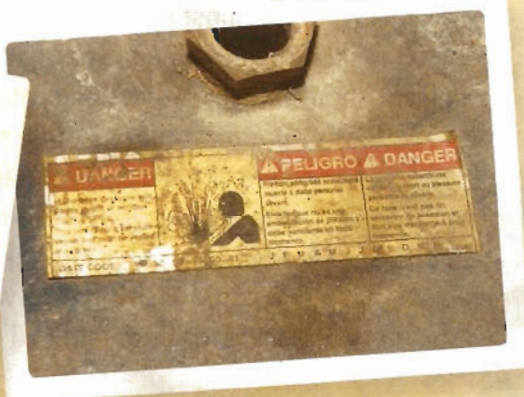
The square, cast-iron condensate tank was not intended to be a pressure vessel. When the inlet valve was open, pressure built to an unsafe level and caused the rupture. Opening the valve on the discharge pipe did not help relieve the pressure because the pump that fed the discharge pipe was still off.

A warning label near the inlet fitting said as much and indicated the tank had to be vented at all times. But the label was covered with dirt, and workers said they were unaware of the need for a vent. Indeed, a vent at the top of the tank had been capped off.

A construction company had installed the tank, working from drawings that did not show a vent line or specify the need to vent the tank to the outdoors. The tank manufacturer said the vent line had been mistakenly omitted from the drawings.

The cast-iron condensate tank ruptured and burned five workers with steam and hot condensate when it was improperly pressurized. A warning label cautions against pressure buildups, but the tank was installed without a vent line to relieve pressure.

After the accident, the mill replaced the ruptured condensate tank with an

ASME-approved pressure-vessel system with pressure gages, relief valves, and lockout-ready power sources. Management also reviewed lockout procedures throughout the plant because the inlet pipe delivering hot condensate to the tank should have been considered an energy source and properly locked out before the workers started their maintenance. **MD**
