Hi-Fi Products
Service Bulletin

Model: CDP-C5F/C5S/C50/C57

No. 40

Subject: Incorrect Disc Count

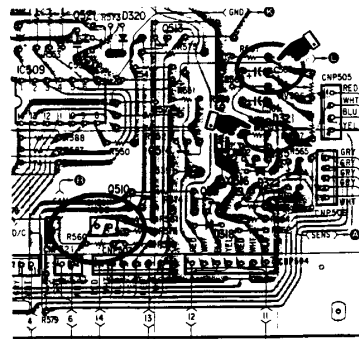
The disc is inserted in a particular receptacle such as #1, but when the draw is closed it stops at another position (usually the next lower or higher). The Led of the incorrect position lights. The disc counting pulses are incorrectly read by IC701.

Solution: Change the value of the following components:

| Ref. No. | Description | |
|---|---|---|
| C560 | 22uf, 25V | 10uf, 25V |
| R593 | 47k, 1/6 watt, 5% | 33k, 1/6 watt, 5% |
