Hi-Fi Products
Service Bulletin

Model: TC-K700ES

No. 7

Subject: Improvement of Wow and Flutter

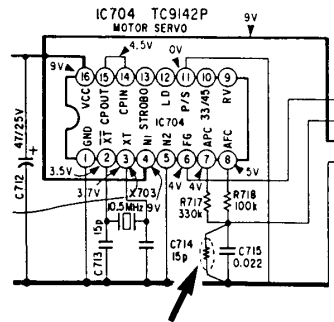
【System Control Board】

Wow and flutter is generated just after play is initiated.

Add an 820K Ω resistor (P/N 1-215-491-00) in parallel with C715 on the system control board.

Mount a 820K Ω resistor here
