Corrections & Updates

Mini Preamp

October 2009, p. 68-71, ref. 090241-1

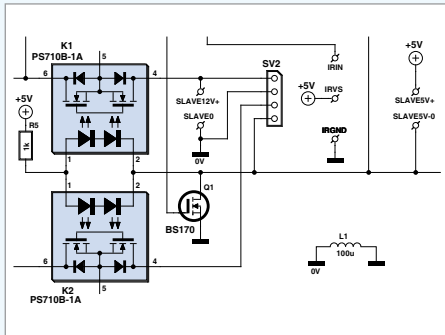
Regrettably a few errors have crept into the circuit diagram in Figures 1 and 2. In Figure 1, components K1 and K2 are drawn incorrectly and an inductor is missing between the analogue and digital ground lines.

The corrected sections of the circuit diagrams are shown here. The electronic version (.pdf) of the article on the Elektor website contains the corrected diagrams.

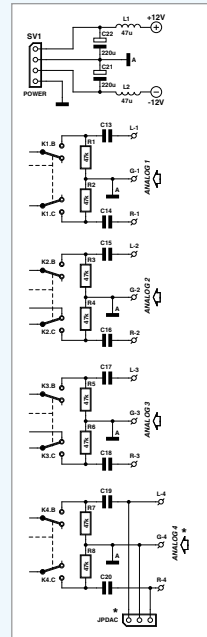
In Figure 2, the relay contacts are drawn incorrectly in their non-actuated state, which suggests all inputs are interconnected. Also, two miniature chokes are missing in the +12 V and -12 V supply lines.
