Repairing the damage caused by leaking batteries

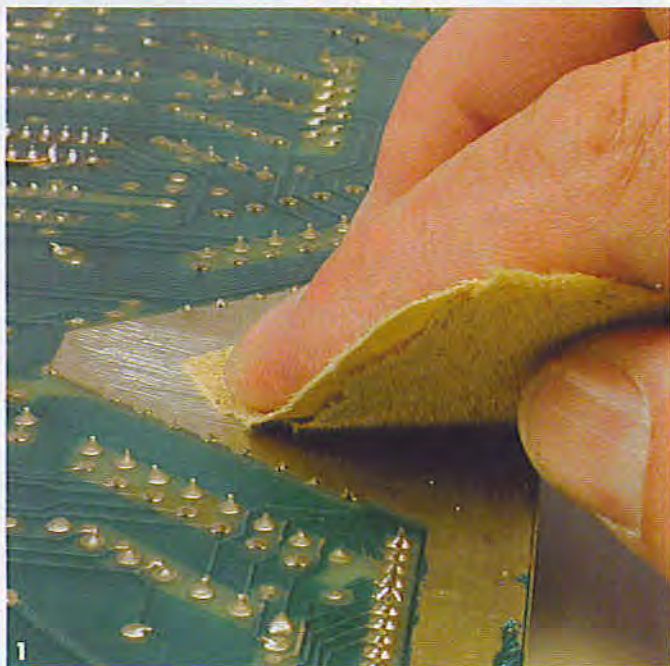
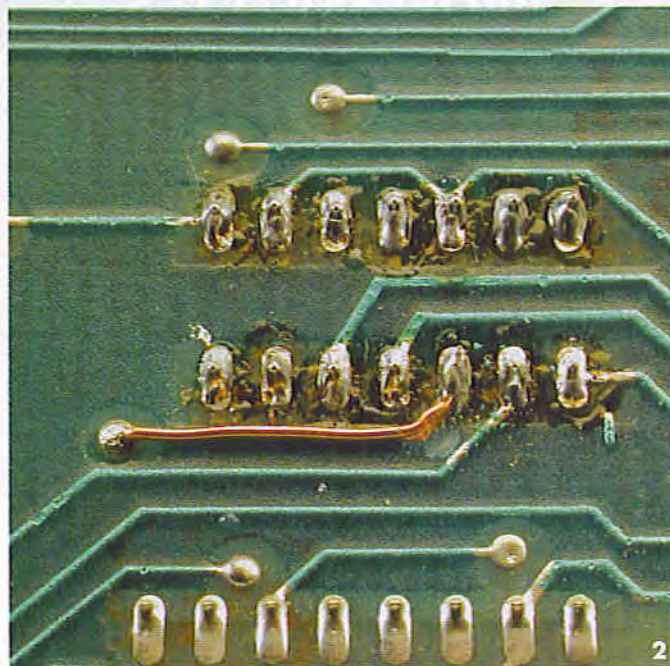
On a PCB the corrosion can be seen in various ways. Firstly as a simple mark where the battery is mounted. Next, it can be seen as a green or white deposit on the pins, components and solder joints.

We start with the removal of all components that are on the affected part of the PCB. Use a good quality solder sucker and/or desoldering braid and keep in mind that in many cases, such as for resistors, capacitors, IC sockets and standard logic ICs, the PCB is more important than the component that has to be removed. In those cases, you can cut the connections and remove them one by one.

When all components have been removed from the corroded part of the PCB, it should be sanded with fine wet-and-dry sandpaper. Any solder resist should be removed as well; you just keep sanding until all tracks become shiny again.

To finish the job properly any remaining electrolyte has to be neutralised by rinsing the PCB in a 1:1 mixture of water and vinegar. It is often thought that all batteries contain acids, but Nicads and alkaline cells have KOH as electrolyte, which is an alkaline. Hence we need to use an acidic solution to neutralise it. After this it should be rinsed with water, dried and then cleaned with alcohol (white spirit is much cheaper, but less pure). The PCB should then be sprayed with a solder lacquer, which protects

The PCB now has to be inspected carefully, and any broken tracks have to be repaired using enamelled copper wire, cut to length. The components can then be soldered back onto the PCB.
