# SERVICEMAN'S LOG

## When in doubt, swap it out

- The art of troubleshooting
- Chromagen water heater repair
- Multiple capacitor replacements

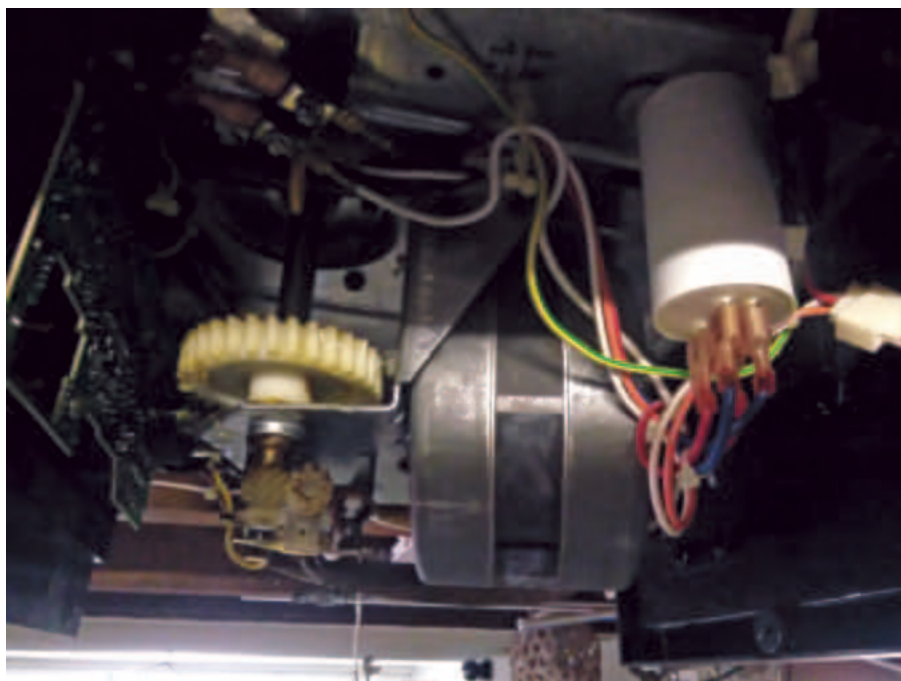
I removed the cover over the drive mechanism mounted to the ceiling of the garage, to see if there was an obvious problem. One of the first things that I saw was the large white motor capacitor. Due to my previous experiences, I decided to look no further and immediately started looking for a replacement.

It was impossible for me to purchase an exact match, as no 12.5 $\mu$ F capacitor was available at our local electrical supplier, but I found one 12 $\mu$ F capacitor in their spares collection, which I had no doubt would be suitable.
