Baler operation takes a **tragic** turn

No warnings, guards, or safety analyses on the route to injury

Extra wiring is a real firestarter

Vent line missing from drawing; five workers burned

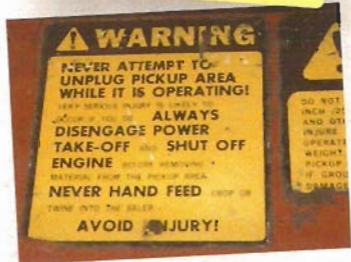
Emergency responders found the farmer's shirt had wrapped around the rotating power take-off (PTO) shaft to the baler, pulling him toward the machine and breaking his neck. He was pronounced dead at the scene.

The farmer had completed some repairs to the round baler before removing it from the equipment dealer's premises, but the machine did not have the manufacturer-supplied guards when he traded for it or when he took it home. The guards are meant to cover the PTO shaft from the tractor, the transmission housing that couples the PTO to the baler shaft, and the baler shaft itself.

Manufacturer-supplied guards should cover the power take-off (PTO) shaft from the tractor, the transmission housing, and the baler shaft. The guards also warn against removing them during operation, approaching rotating components, and servicing the baler without disconnecting the PTO.

Investigators determined the accident would not have happened if the guards had been present or if the farmer had disconnected the baler from the PTO before trying to remove the blockage.
