Making a clock chip keep better time

by M. F. Smith

Department of Computer Science, University of Reading, England

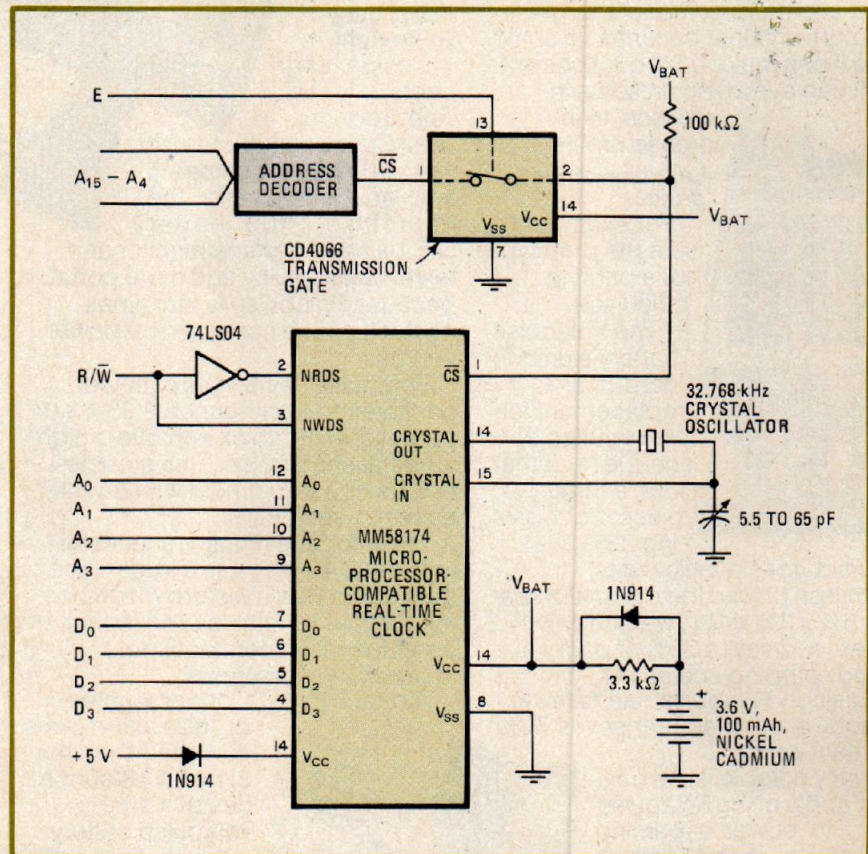
Glitch-free. The CD4066 transmission gate prevents loss of time-date information that is associated with an MM58174 hardware clock during a power-down condition. Read errors in time-date information may be eliminated in the software of a microprocessor system by writing a loop to ensure the program does not advance until the data has definitely been read correctly.

Trying to write to the clock chip when the power is going down will ordinarily cause a loss of timing information. A number of methods of preventing the loss were tried, and the one in the figure was the simplest and most successful.

Here, the CD4066 electronic switch will allow the chip to be selected only when the MC6800 clock enables
