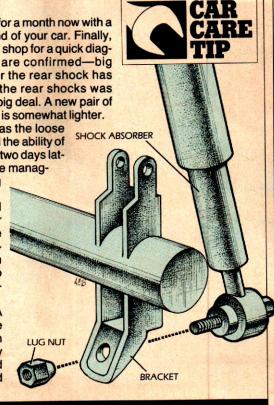
Try the coward's way out. A lug nut just happens to have the same ½-in. threads. With its chamfered face, it'll usually find a home in that egg-shaped hole, snugging up tight and staying that way.

You've been driving around for a month now with a rattling noise from the back end of your car. Finally, you manage to sneak it into the shop for a quick diagnosis, and your worst fears are confirmed—big bucks. The mounting stud for the rear shock has come adrift. Well, replacing the rear shocks was overdue anyway, so that's no big deal. A new pair of dampers go on and your wallet is somewhat lighter.

Unfortunately, that noise was the loose stud enlarging the hole beyond the ability of the hardware to stay tight. And two days later, it's back. The shop's service managers are it's your fault for waiting.
