Video Products
Service Bulletin

Model: SLV-353UC/373UC/555UC/575UC/676UC/
757UC/P33/R5UC

No. 152

Subject: Does Not Load Cassette

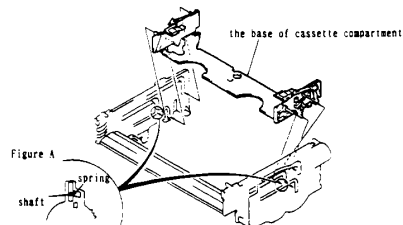
- (4) Assemble the base of the cassette compartment.

- ① Engage the axles (six places) of the base of the cassette compartment in the grooves of the side board of the cassette compartment. (See Figure A).

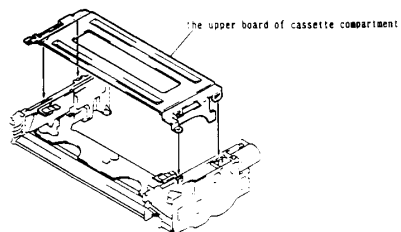
- (5) Assemble the upper board of the cassette compartment.
