## DOT'S WHAT'S MISSING

Who would believe it? You know those little dots on our schematics that indicate whether or not there is a connection between two intersecting lines? Well, it seems that one of those dots decided to pack it in early, leaving Fig. 1 of the Alpha/Meditation Goggle story (**Radio-Electronics**, April 1989) with a definite dot deficiency.

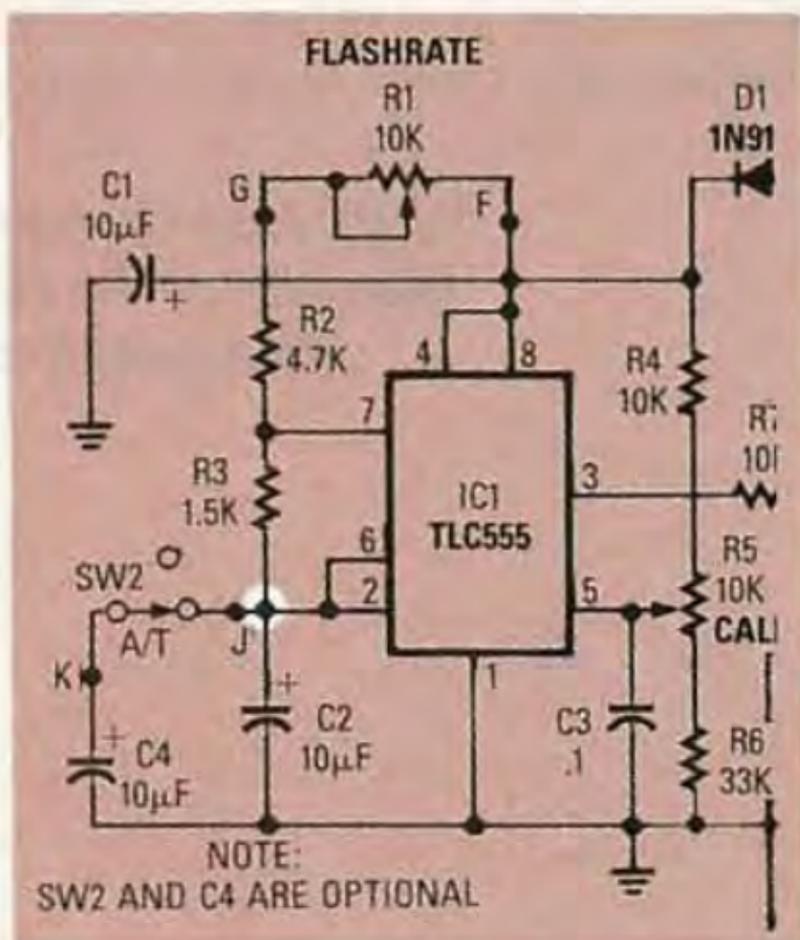
**FIG. 1**

The missing dot belongs at the intersection of R3, C2, and pins 2 and 6 of IC1. We have reprinted a portion of the original schematic, along with the correction, in Fig. 1 above.—*Editor*
